Ideal technique to restore a deep carious premolar tooth using Aura (SDI Ltd.) composite system

BY
DR GRAEME
MILICICH

CASE STUDY

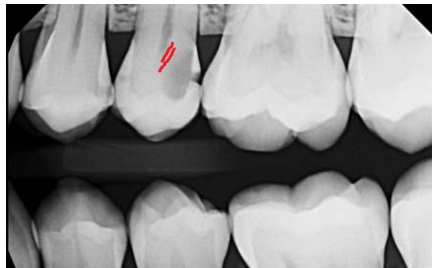
The depth of the decay in relation to the pulp was highlighted in red on the Xray for the patient to see in order to emphasize at the exam appointment that she needed to make an appointment immediately, before the pulp got infected. It was already reacting with reactionary secondary dentine. **(Fig 1)**

Fig 1. The depth of the decay in relation to the pulp was highlighted in red.

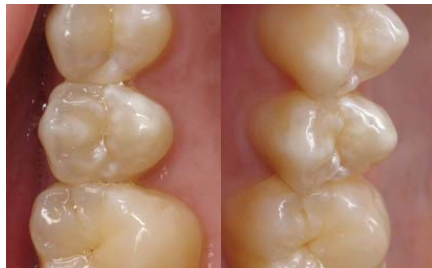
Pre-treatment image. Absolutely no clinical sign of the depth of the decay. **(Fig 2)**

Fig 2. Pre-treatment image.

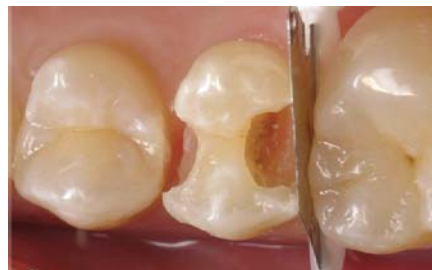
Initial cavity prep and bevelled margins. Sound dentin periphery, some slightly affected dentine over the pulp. **(Fig 3)**

Fig 3. Initial cavity prep and bevelled margins.

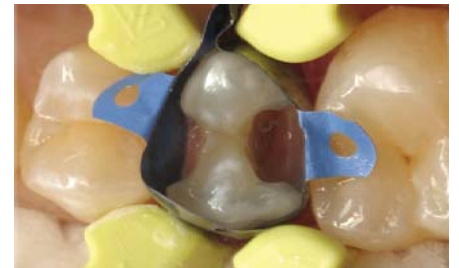
The enamel margins were selectively etched then bonded with a two step self-etching primer and resin. **(Fig 4)**

Fig 4. The enamel margins were selectively etched then bonded.

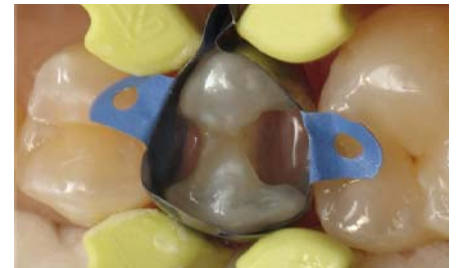
A thin layer of radio-opaque flowable composite such as Wave (SDI Ltd.) was then applied and cured. **(Fig 5)**

Fig 5. A thin layer of radio-opaque flowable composite was applied.

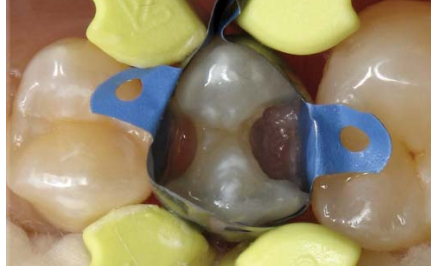
A layer of Ribbon Thin High Modulus Ultra was placed into a thin layer of composite and pressed through to the underlying set flowable composite. (Fig 6)

Fig 6. A layer of Ribbon Thin High Modulus Ultra was placed.

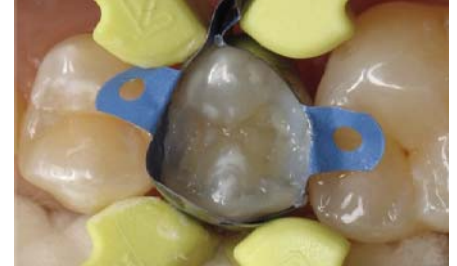
Final contoured increment of Aura DC5. (Fig 10)

Fig 10. Final contoured increment of Aura DC5.

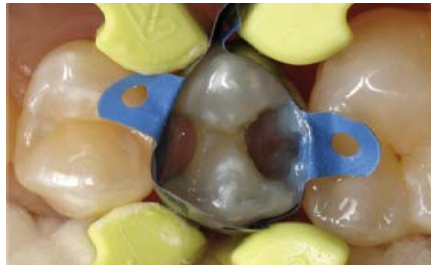
Aura E1 enamel shade was used to create the marginal ridge and was sectioned vertically to control C-Factor shrinkage stresses. (Fig 7)

Fig 7. Aura E1 enamel shade was used to create the marginal ridge.

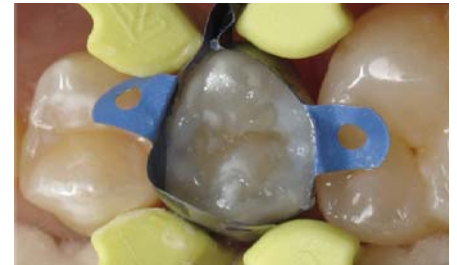
Aura E1 enamel shade contoured over the dentine base. (Fig 11)

Fig 11. Aura E1 enamel shade contoured over the dentine base.

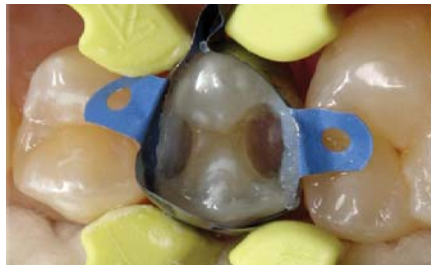
The marginal ridges were completed with a further increment of Aura E1. (Fig 8)

Fig 8. The marginal ridges were completed.

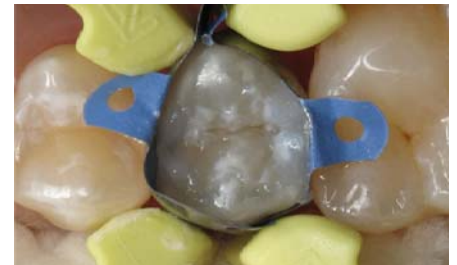
An opaque white tint was added to duplicate the pre-treatment shade of the tooth. By bringing the darker Aura DC5 dentine shade up to the correct depth, contouring of the enamel layer exposed the darker dentine shade, creating a colour depth to the fissures. (Fig 12)

Fig 12. An opaque white tint was added to duplicate the pre-treatment.

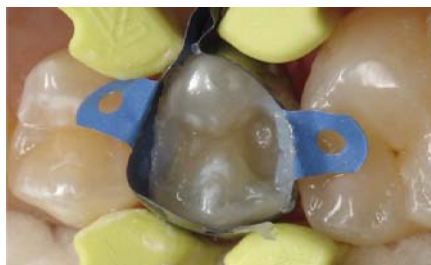
Aura DC5 was built up in 1mm increments. (Fig 9)

Fig 9. Aura DC5 was built up in 1mm increments.

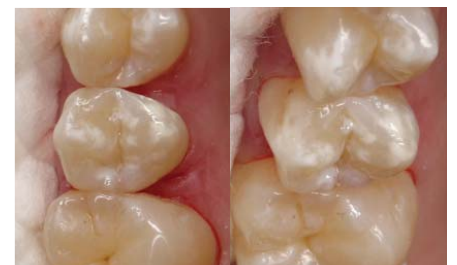
Final restored tooth. (Fig 13)

Fig 13. Final restored tooth.
